# *Fermoy Weir and Fish Bypass Channel*

*September 2020*

# Fermoy Weir

**Over 200 years old - A Protected Structure**

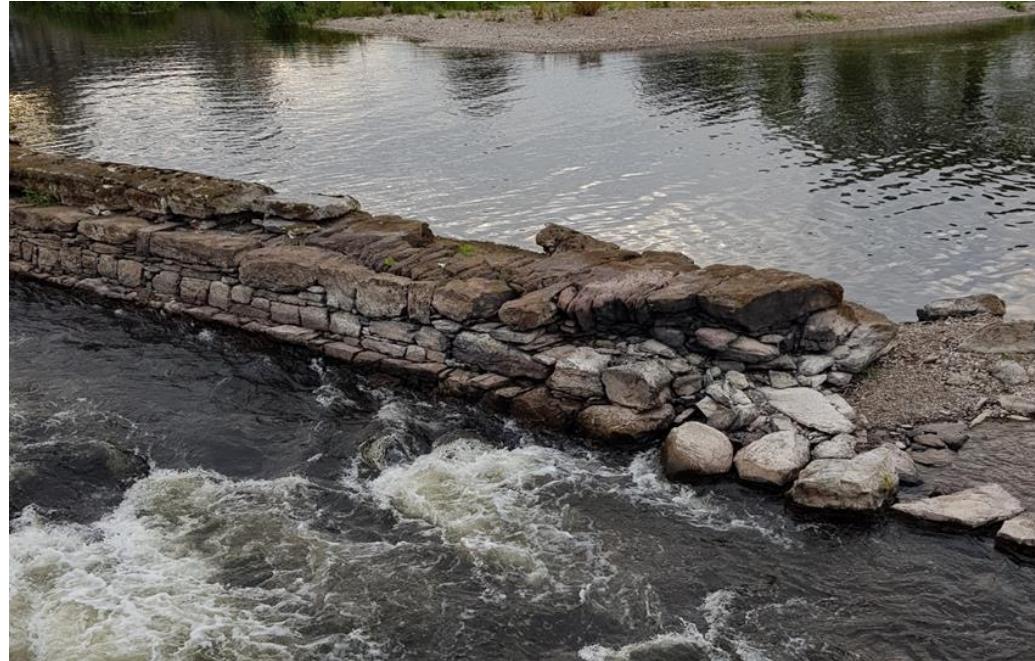
## Mill Race Weir Wall

- ❑ loss of grout
- ❑ Open Joints
- ❑ Loose masonry

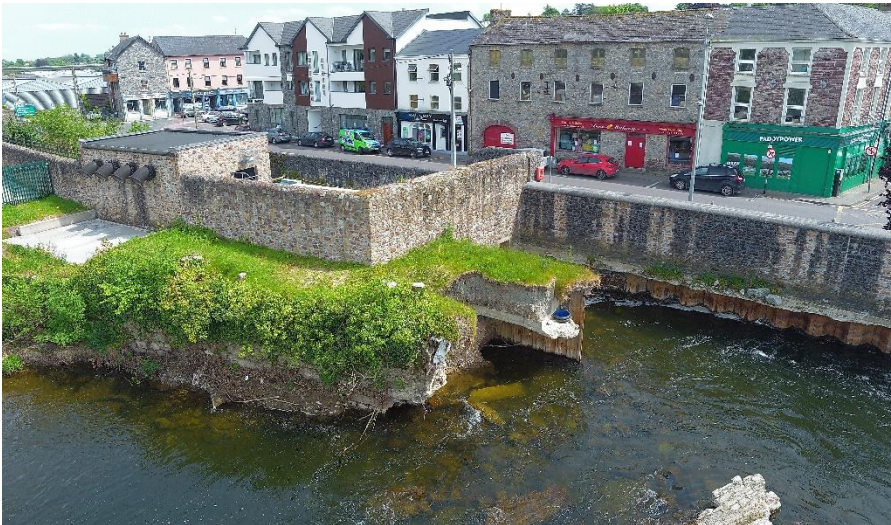
- ▶ CCC obliged to prevent deterioration of weir
- ▶ Weir breached and in poor Condition
- ▶ Leading to bank and bed erosion

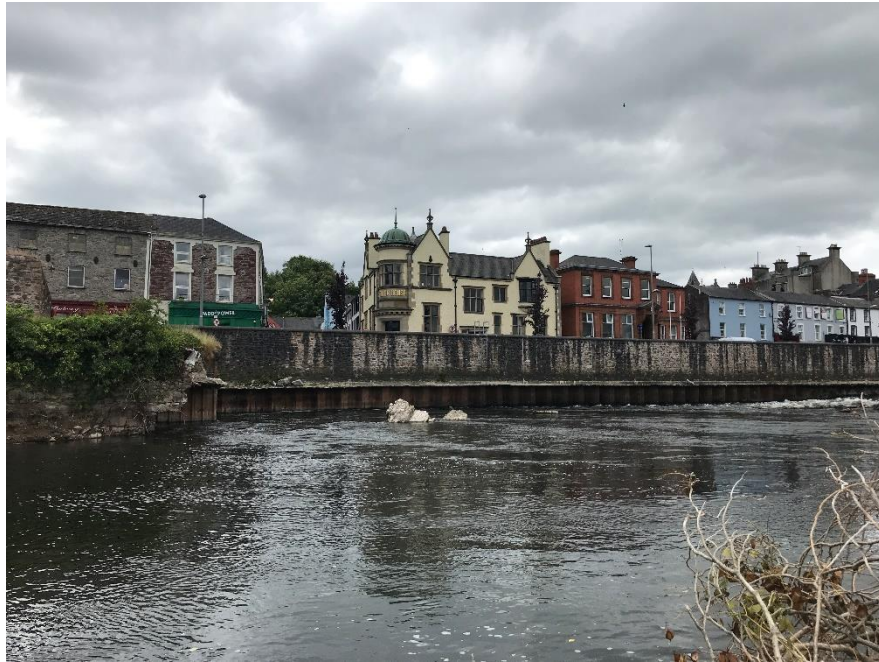
Erosion of Bed and Bank **leading to real risk of undermining** of flood defence structures

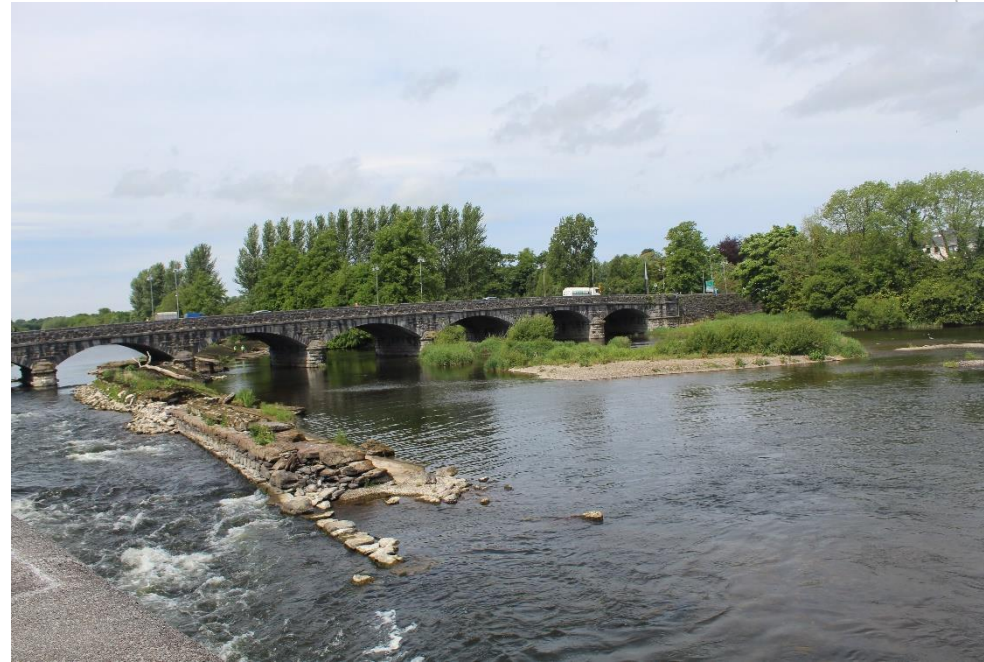
Velocities in low flow conditions are a hindrance to fish passage

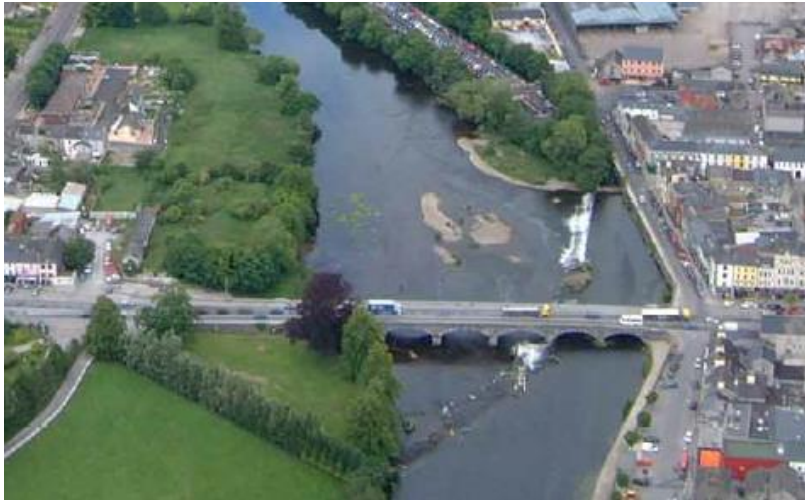
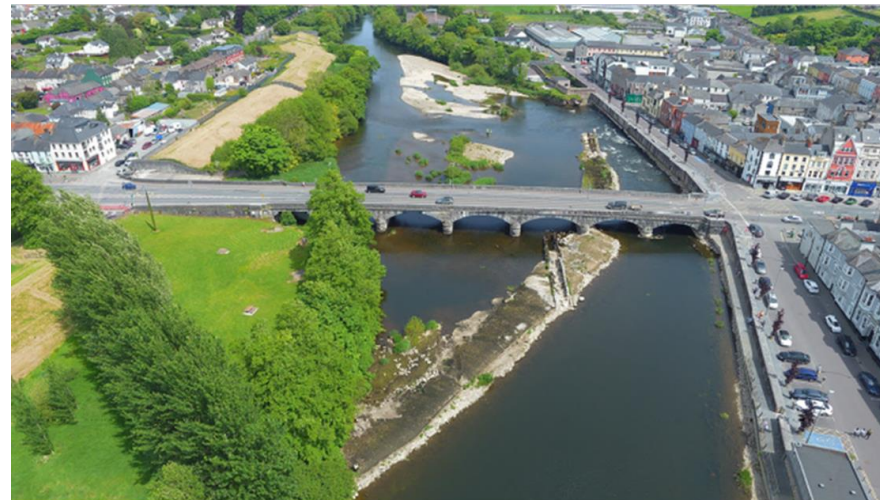
# Increased flows lead to increased gravel

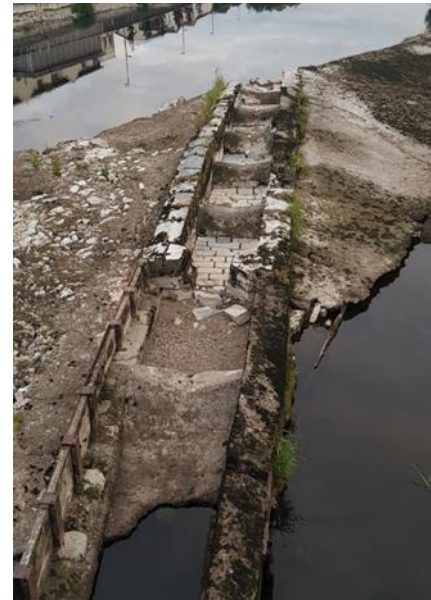
Fish Pass Today

Not ideally situated in weir  
Does not provide for passage of all fish
