FERMOY WEIR REMEDIATION AND FISH BYPASS CHANNEL

Options Report

Project Name: Fermoy Weir Remediation and Fish Bypass Channel Project

Document Title: Options Report

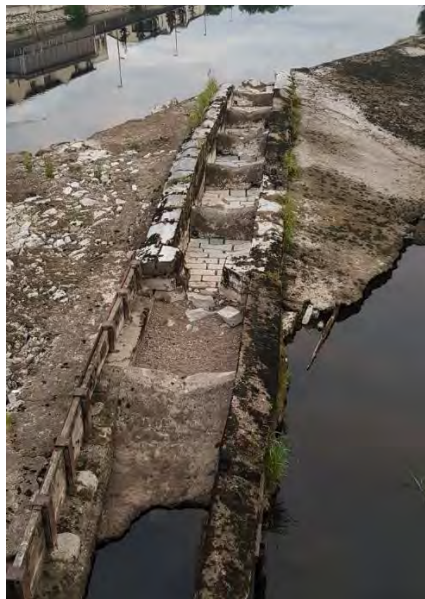
Figure 1-3: Fermoy Fish Pass – July 2019

The existing fish pass is of masonry construction as can be seen in Figure 1-3 below. According to Fisheries Ireland its diagonal position in the centre of the river is not suited for the successful passage of migrating fish.

The fish pass is located towards the centre of the weir. This means that the white-water attraction at the entrance to the fish pass is not ideally situated. The optimum location for the entrance to a fish pass on a diagonal weir should be at the furthest upstream point on the downstream side of the weir.

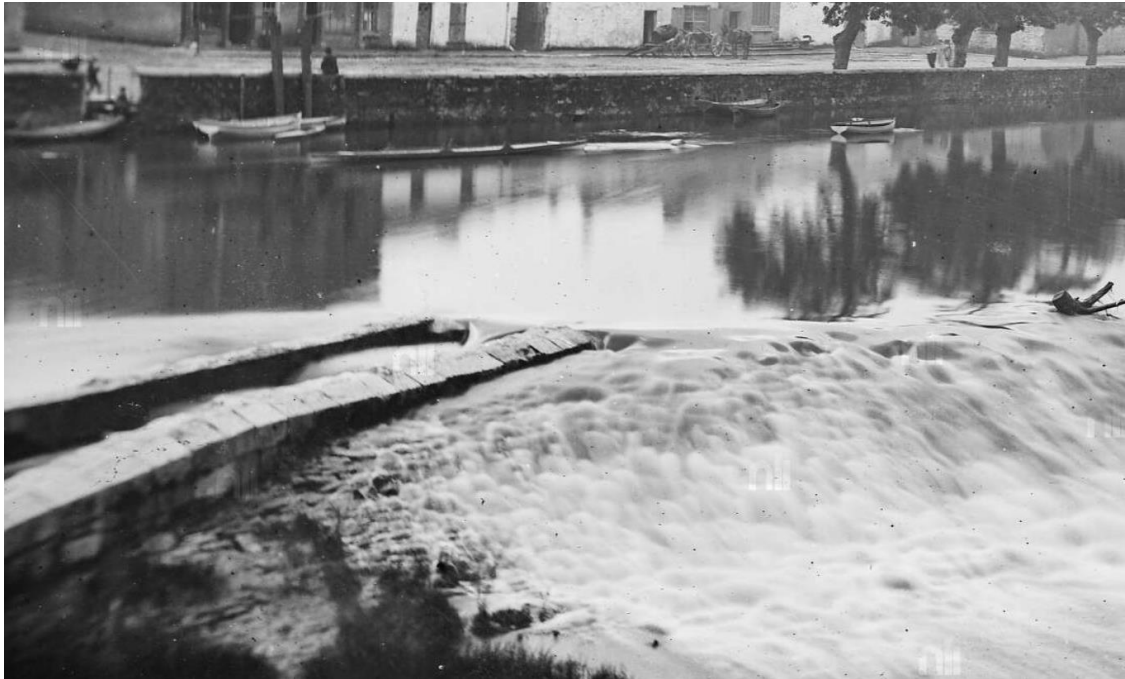
Figure 1-4: Fermoy Fish Pass – Eblana Collection (ca. 1870-1890)

The Fish Pass was referred to as the Salmon Leap in the past and photographs exist in the National Library Digital Online Collection showing the structure in the 19th Century. Two Photographs are reproduced at Figures 1-4 and 1-5 below. Figure 1-4 is an enlargement from a photograph from the Eblana Collection dated in the region 1860-1880. Figure 1-5 is an enlargement from a photograph from the Lawrence Collection dating from 1894 when a series of photographs were taken around the town of Fermoy, including several which included views of the weir.

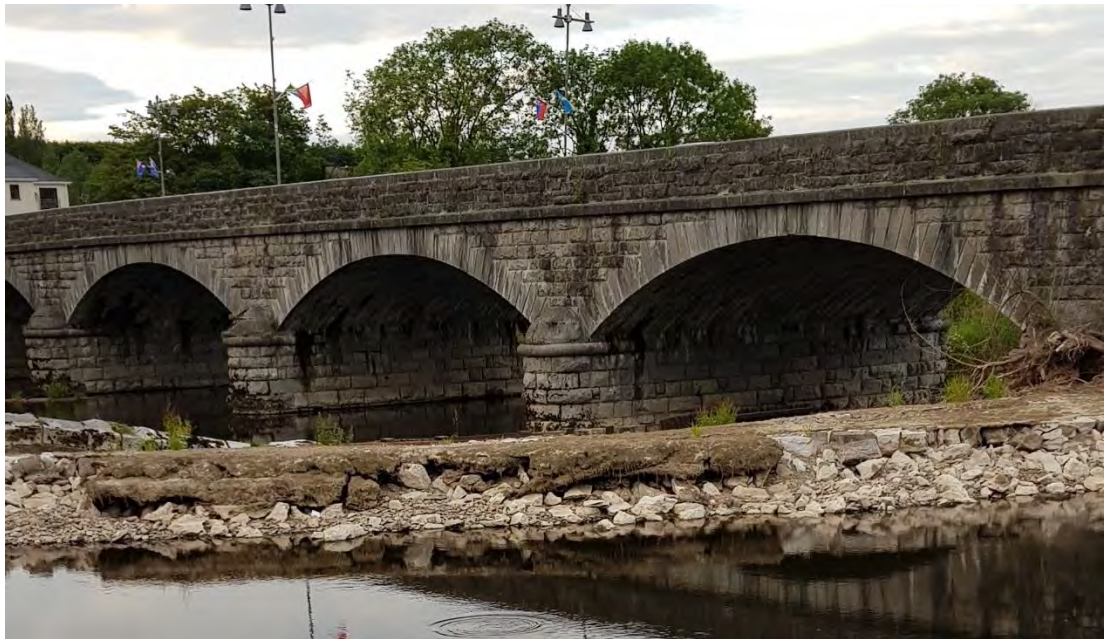
Figure 1-6: Fermoy Weir Upstream – July 2019

The existing Fermoy weir is of masonry and rubble construction as can be seen in Fig 1-6. It traverses the river Blackwater, extending diagonally from the north bank to the second pier of the bridge out from the southern bank of the river. The weir then runs in an easterly direction along the bridge pier and extends east of the bridge to the mouth of the Mill Race

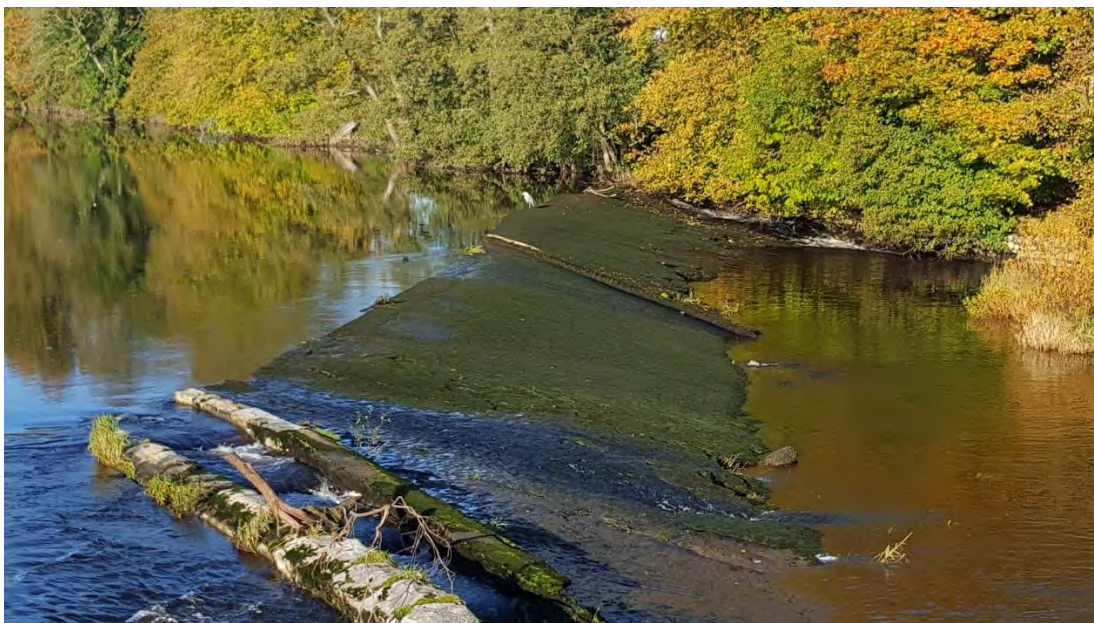
Figure 1-10: Fermoy Weir Concrete Apron (Upstream) – July 2019

A concrete apron (or screed) was placed over the masonry structure of the weir (Figure 1-10), upstream of the Mill Race Weir wall, by Fermoy Town Council at some stage in the past. It is understood that this occurred in the 1970's. Erosion of this apron has exposed

mesh reinforcement in places. However, it is not known if the mesh reinforcement was used throughout the full extent of the apron. There is evidence that the screed was also applied as a capping to the Mill Race Weir Wall structure at the same time. In the intervening decades the concrete apron or screed had suffered erosion and impact damage and, in many sections, has failed completely.

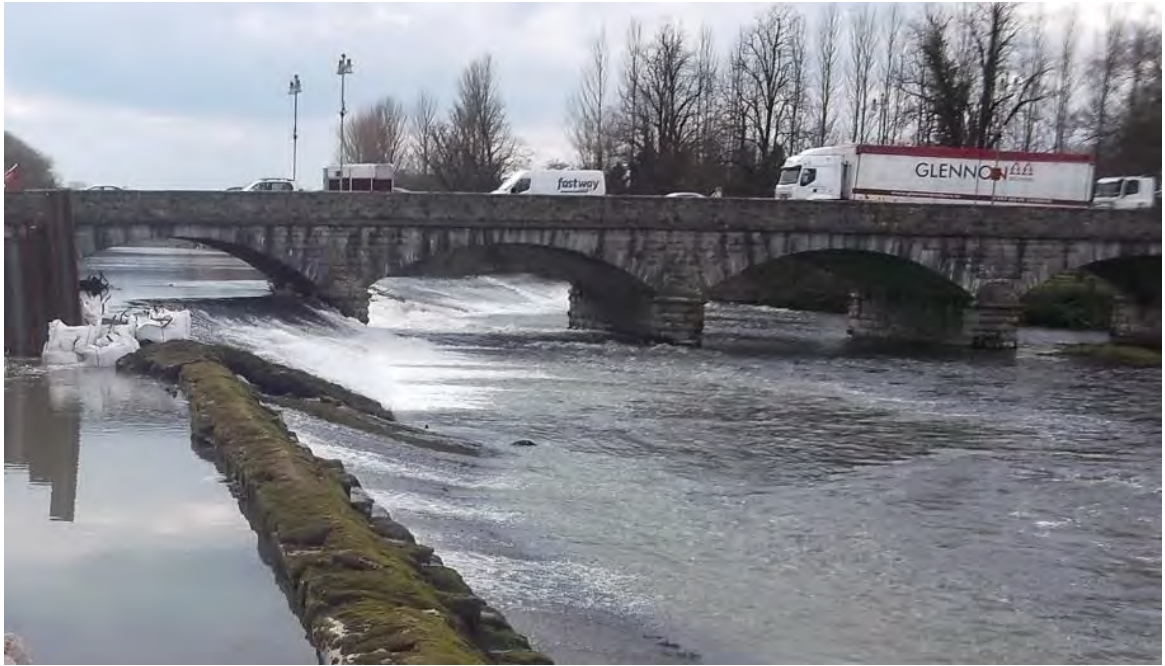
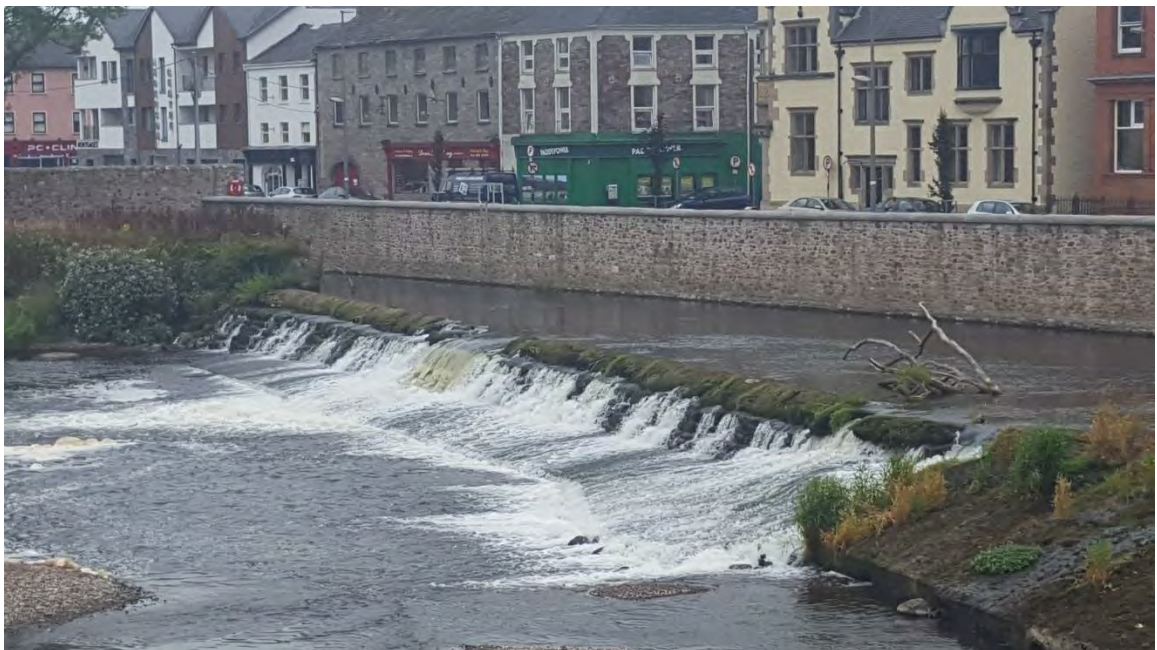
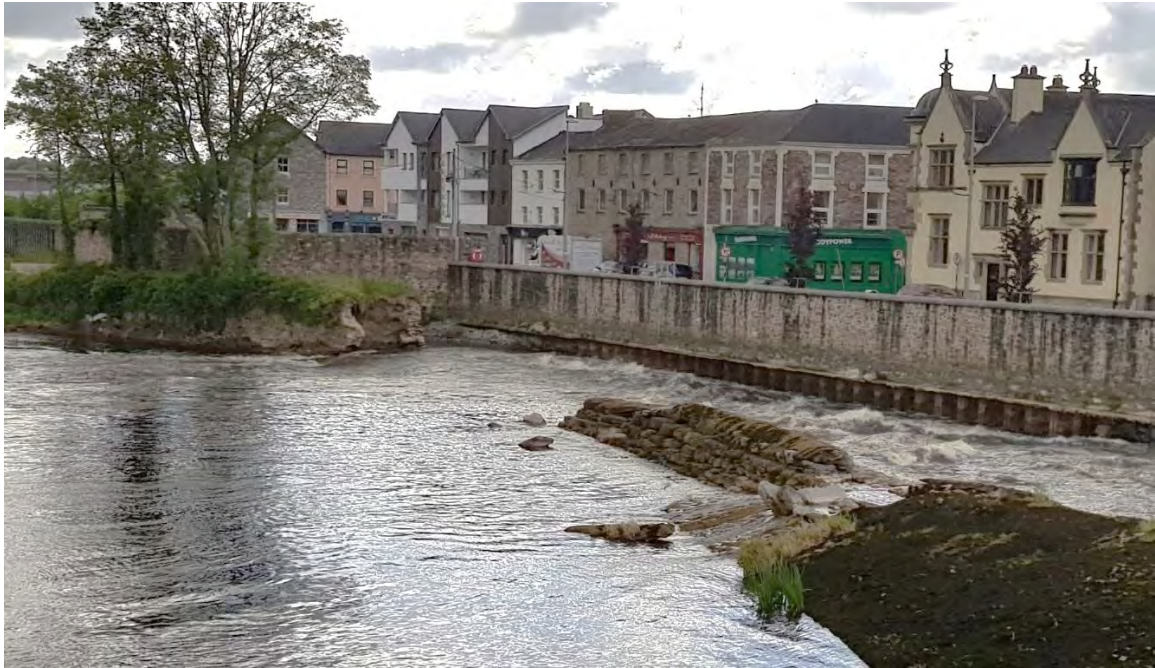
The weir has deteriorated significantly in the past number of years since this was first highlighted by Inland Fisheries Ireland (IFI) in 2016. The Mill Race section of the weir in particular has deteriorated considerably as shown in Figures 1-11, 1-12 and 1-13 below.

Figure 1-11: Fermoy Weir – Mill Race Weir Wall March 2013

Figure 1-12: Fermoy Weir – Mill Race Weir Wall August 2016

Figure 1-13: Fermoy Weir – Mill Race Weir Wall June 2019

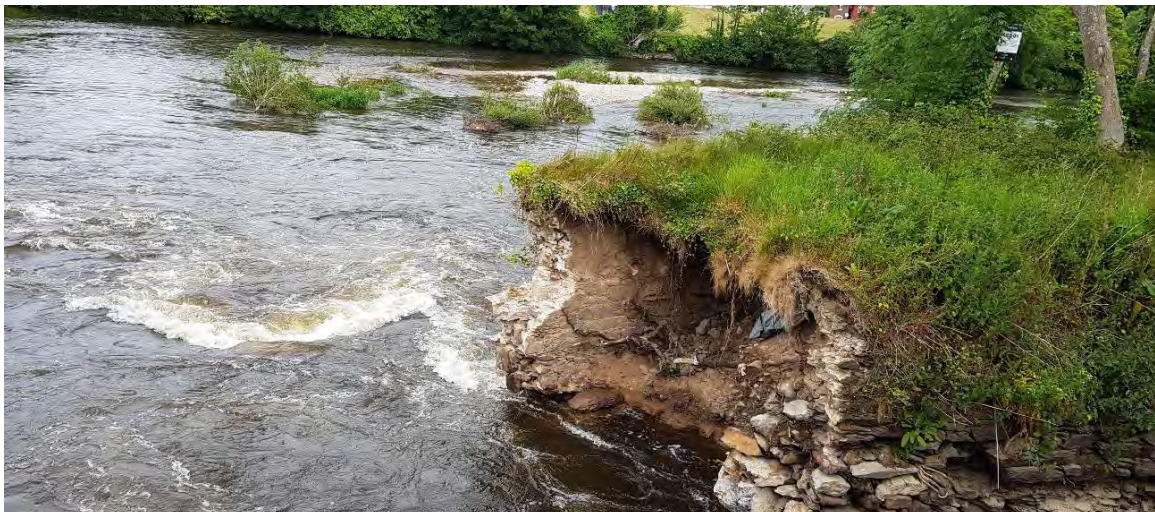
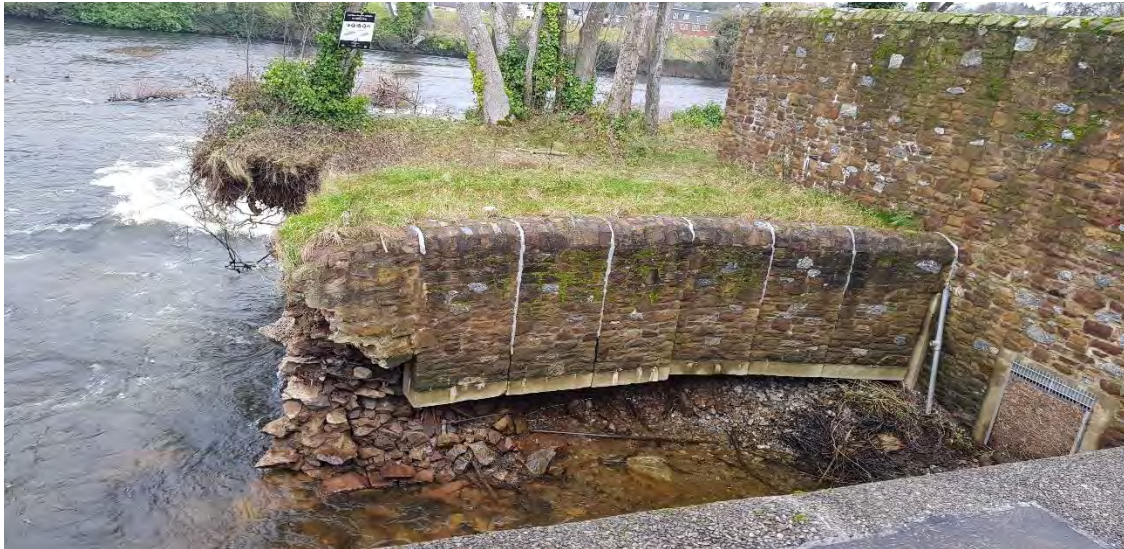
The damage to the weir is at its most severe at the eastern end of the Mill Race Weir wall where significant erosion has occurred as shown in Figures 1-14 and 1-15 below.

Figure 1-14: Fermoy Weir – East End of Mill Race Weir Wall June 2019

Figure 1-15: Fermoy Weir – East End of Mill Race Weir Wall December 2019

The effect of the ongoing breach in the weir is that normal flow in the river Blackwater does not spill over the weir. Instead, the flow in the river is directed through an increasingly narrow section of channel between the Mill Race Weir Wall and O'Neill Crowley Quay before passing through the breach in the weir. The velocity of flow within this narrow channel is very high and is almost always in excess of 2m/s. This resultant turbulent flow has contributed to the progressive nature of the breach and to the ongoing erosion of the river bed alongside O'Neill Crowley Quay and of the river bank at Mill Island, threatening the stability of the flood defence infrastructure.

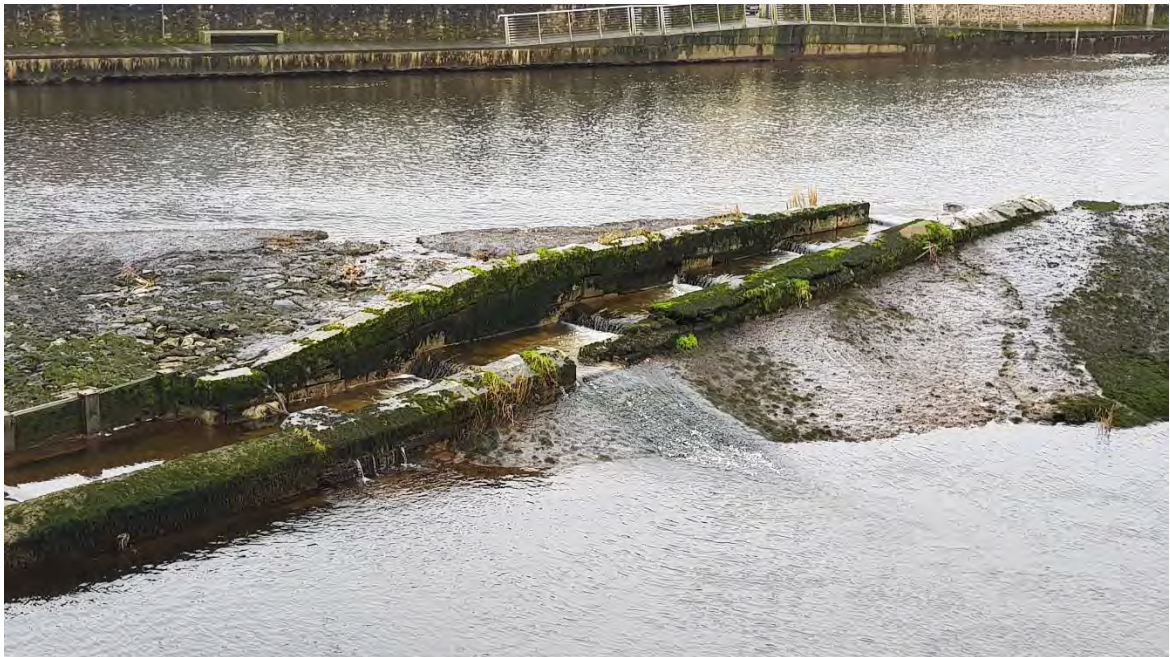
Figure 4-1: Existing Fish Pass at Fermoy Weir - November 2019

This option consists of repairing the existing fish pass. The existing fish pass is a technical type fish pass, comprising a masonry stepped structure located within the weir structure close to the midpoint of the river. The fish pass crosses the weir on a diagonal to decrease the gradient and increase the number of steps in the structure. Damage to the lower part of the structure was repaired in 2013. Since then further damage has occurred and part of

the side wall of the pass, on the downstream facing side of the structure, has been breached.

It had been proposed to retain the upper section of the fish pass structure and demolish and replace the lower section with a new in-situ concrete structure. A new channel was proposed to be created in the river bed to create an attraction flow in the river at the entrance to the fish pass.

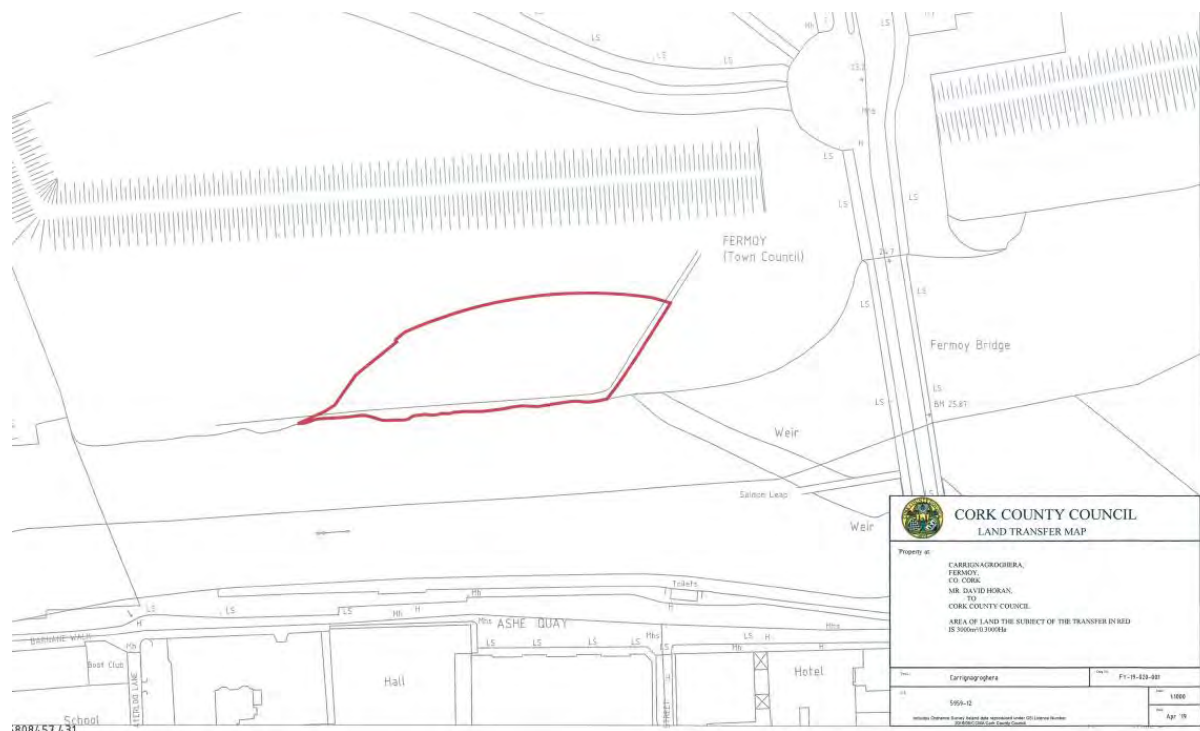
Figure 4-3: Land and Easements to be Acquired for Proposed Works

A potential fish bypass channel in the northern bank of the Blackwater river (as envisaged in Options 7, 8 and 9) would require a section of land to be acquired by Cork County Council in order to facilitate its construction. A portion of land forming part of Folio No. CK24179L (Plan No. DCMW3) would need to be acquired as illustrated by Figure 4-3 below.

The section of land adjoining Fermoy bridge, known locally as the Triangle or Circus field would also be impacted by the proposed bypass channel. However, this section of land is not registered according to the Land Direct website but is understood to be in the ownership of Cork County Council.

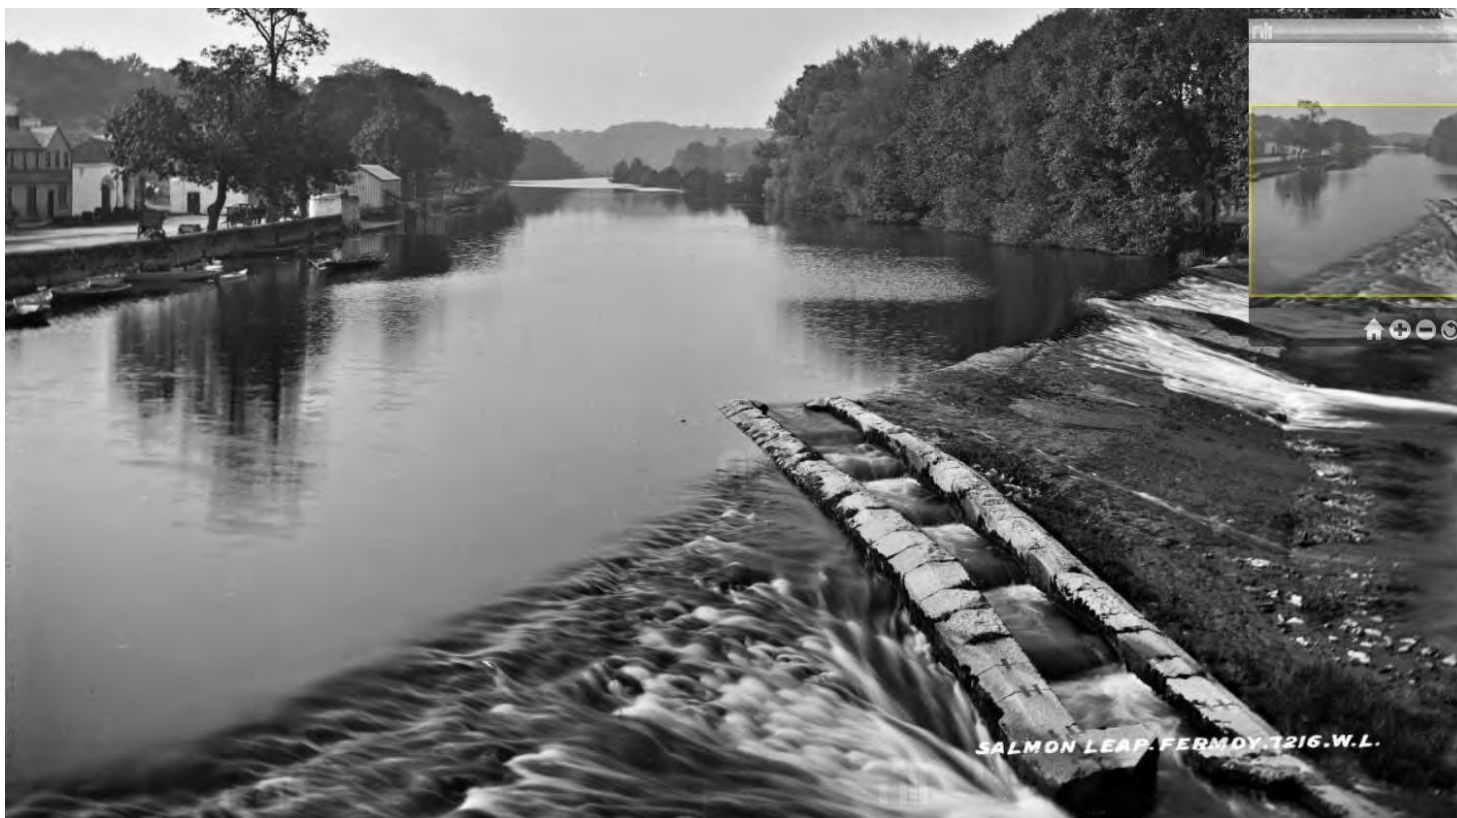
Salmon Leap, Fermoy, Co. Cork [graphic]
by French, Robert, 1841-1917 photographer
Published / Created: [between ca. 1865-1914].
In collection: The Lawrence Photograph Collection
“...Salmon Leap. Fermoy. 7216. W. L....”

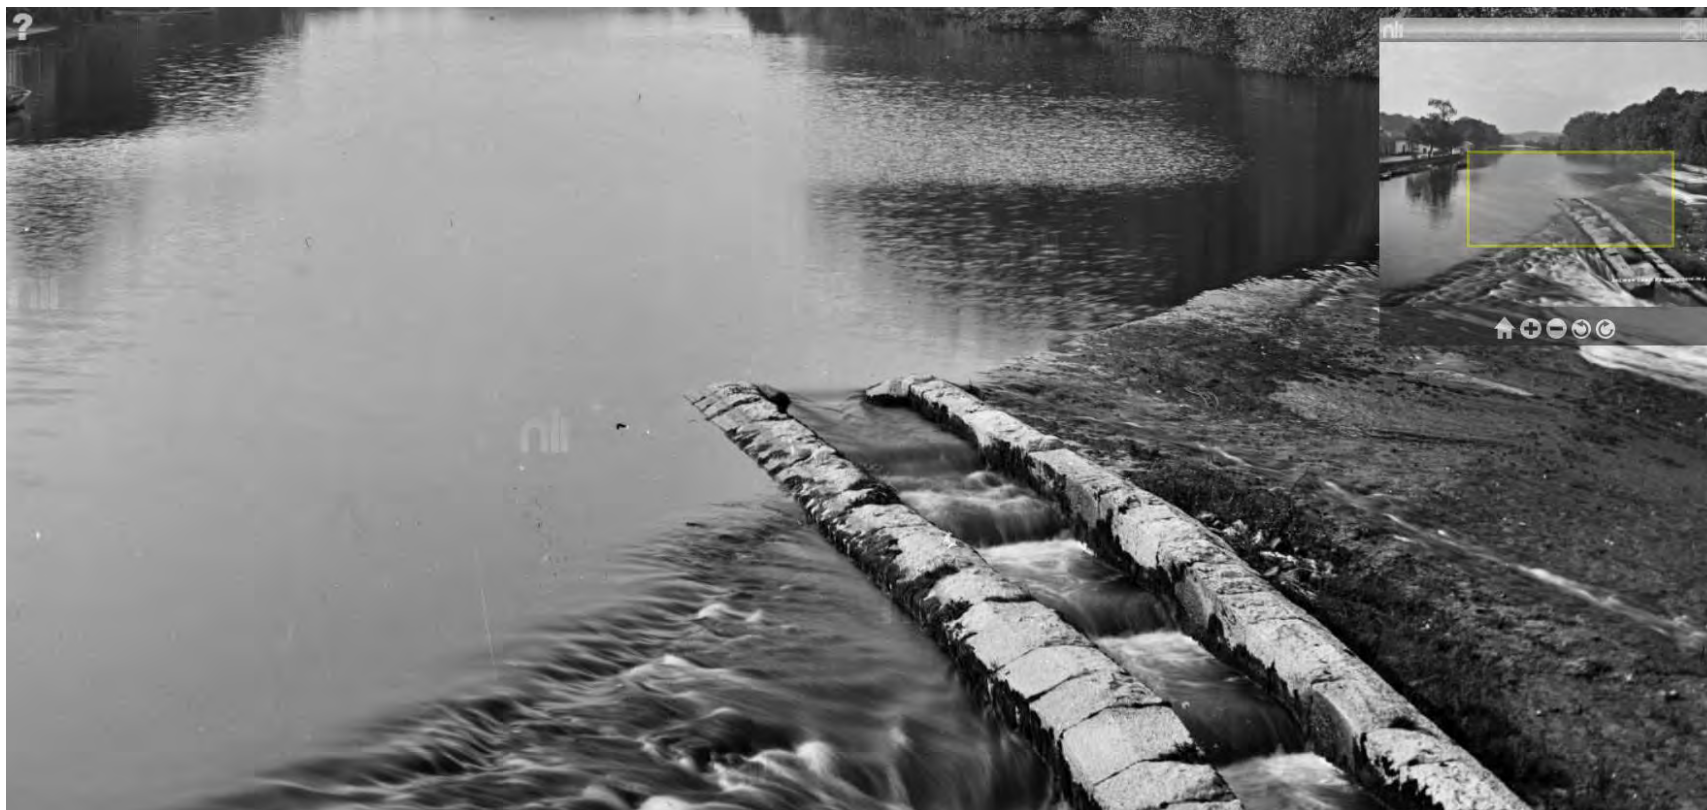
Enlargement of Above showing weir crest close to top of masonry blockwork at Fish Pass

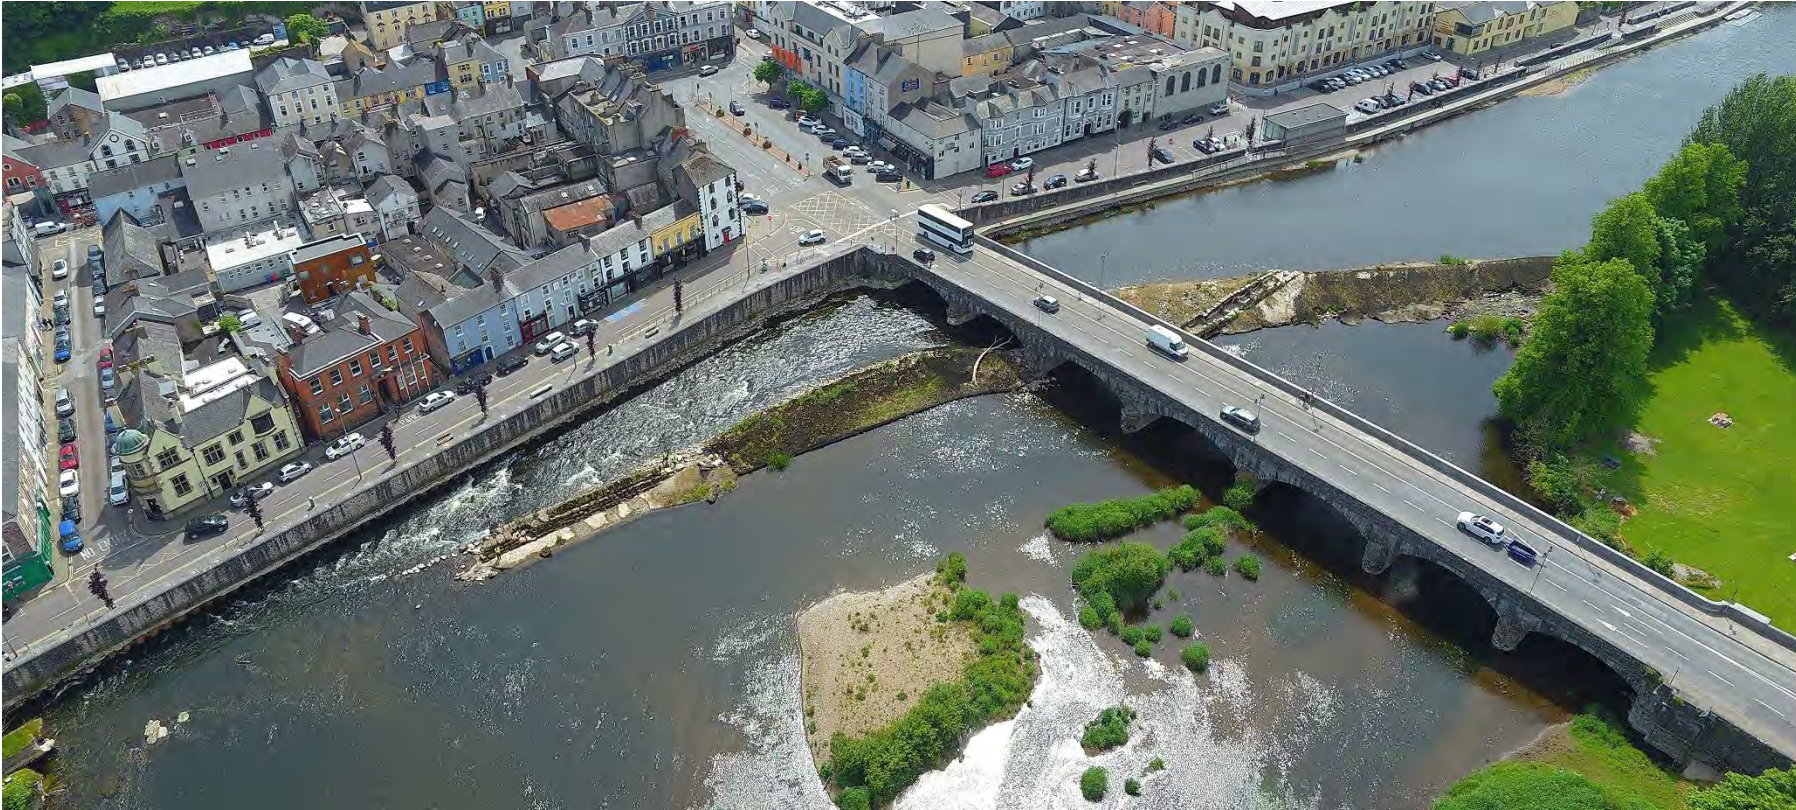
1. Do Nothing

Leave existing situation as is
Weir will continue to deteriorate

Complete collapse will eventually allow fish migration
Bank and bed erosion could undermine flood defences

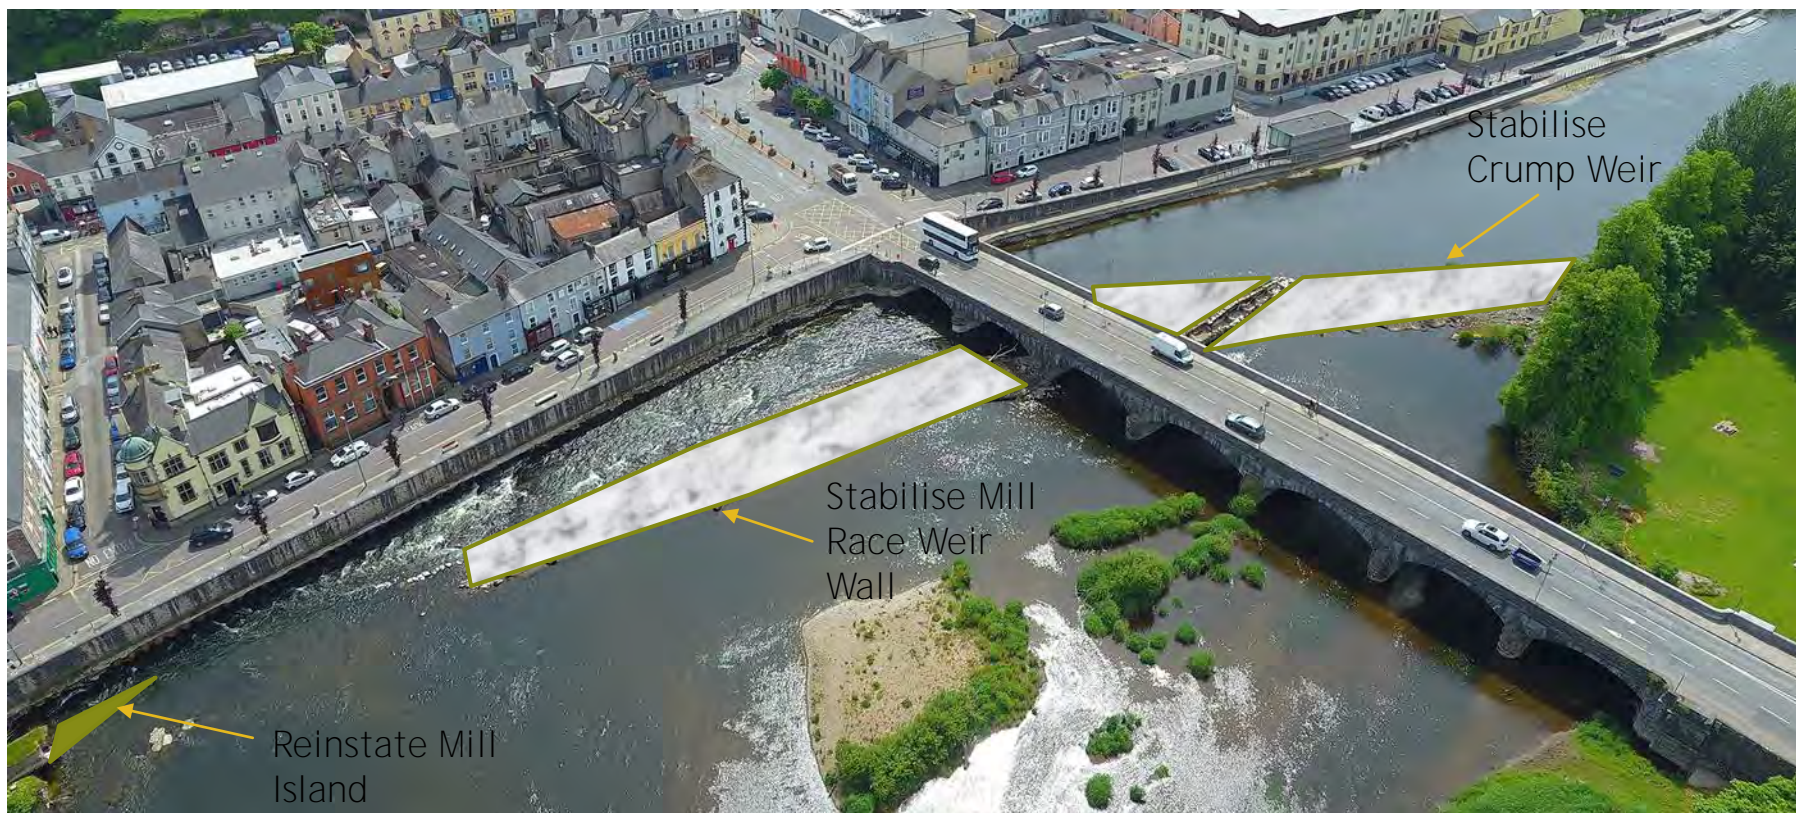
2. Stabilise remaining section of weir

Leave existing breach in place

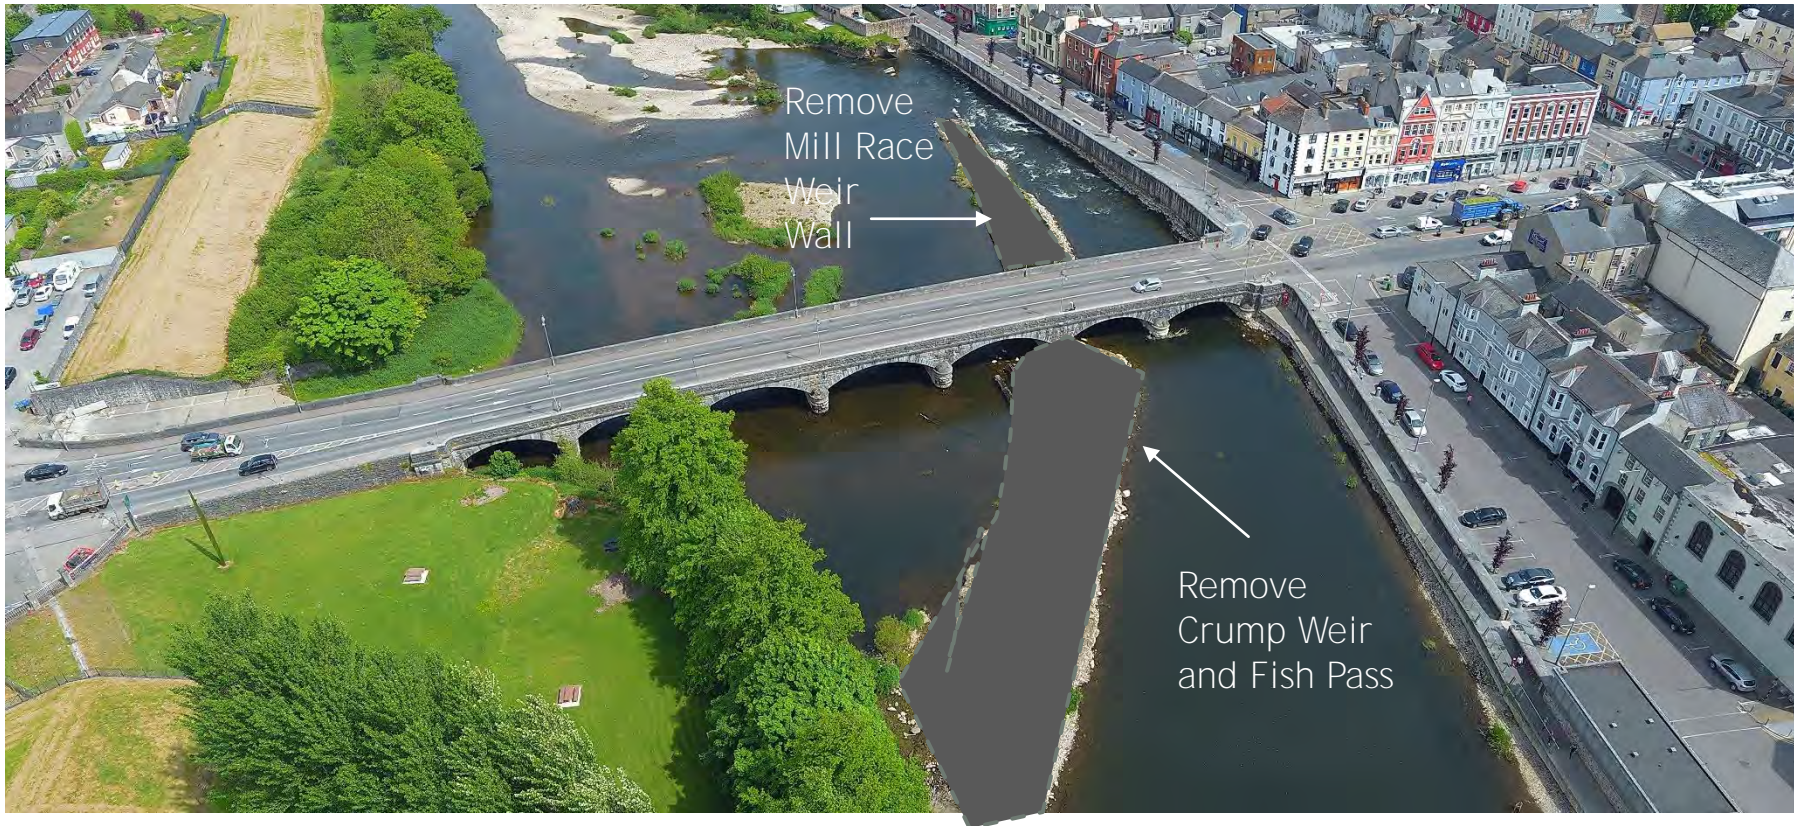
4. Complete removal of the weir

Provides for free passage of fish

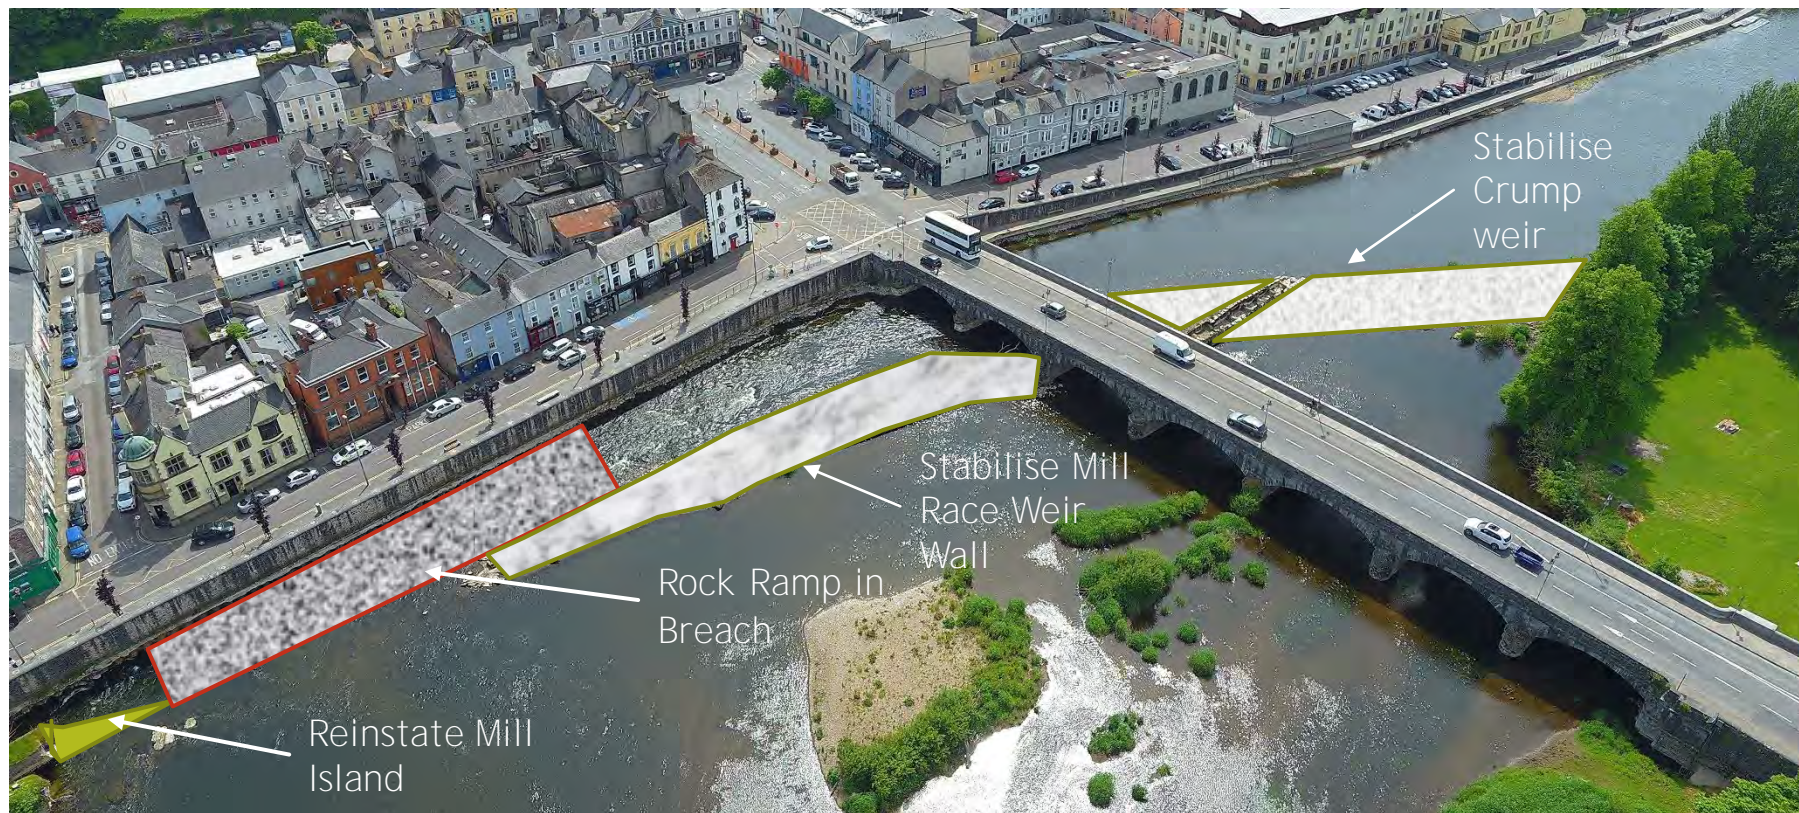
6. Fish Ramp (rock ramp) in the Existing Breach

Ramp not ideally located to attract fish

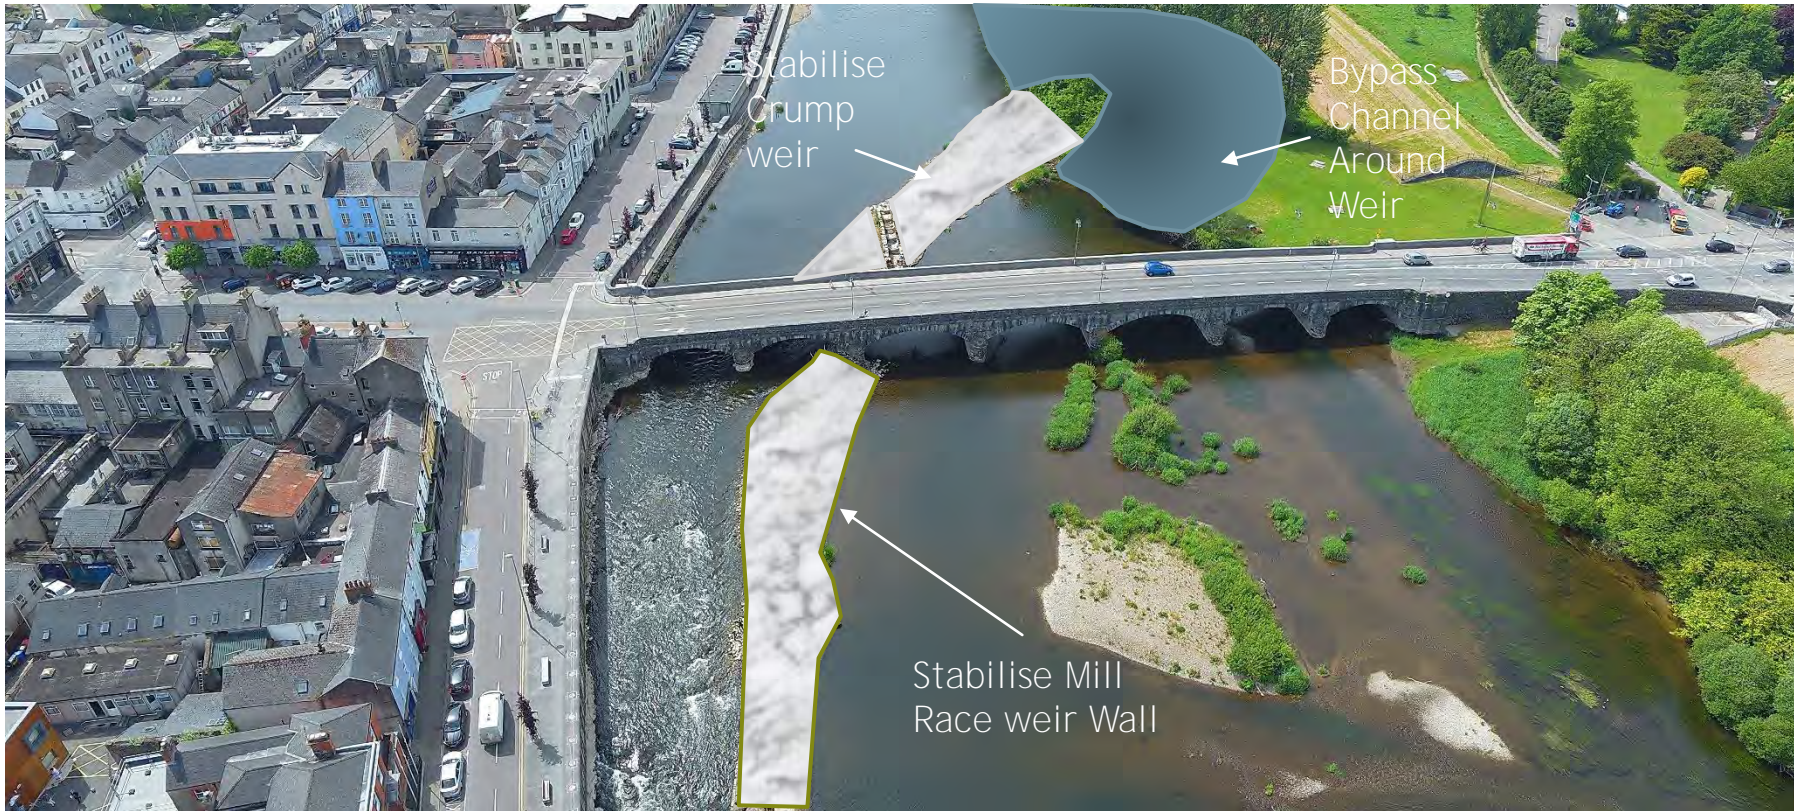
8. Bypass Channel Around Weir

Large flow to be accommodated in Bypass channel

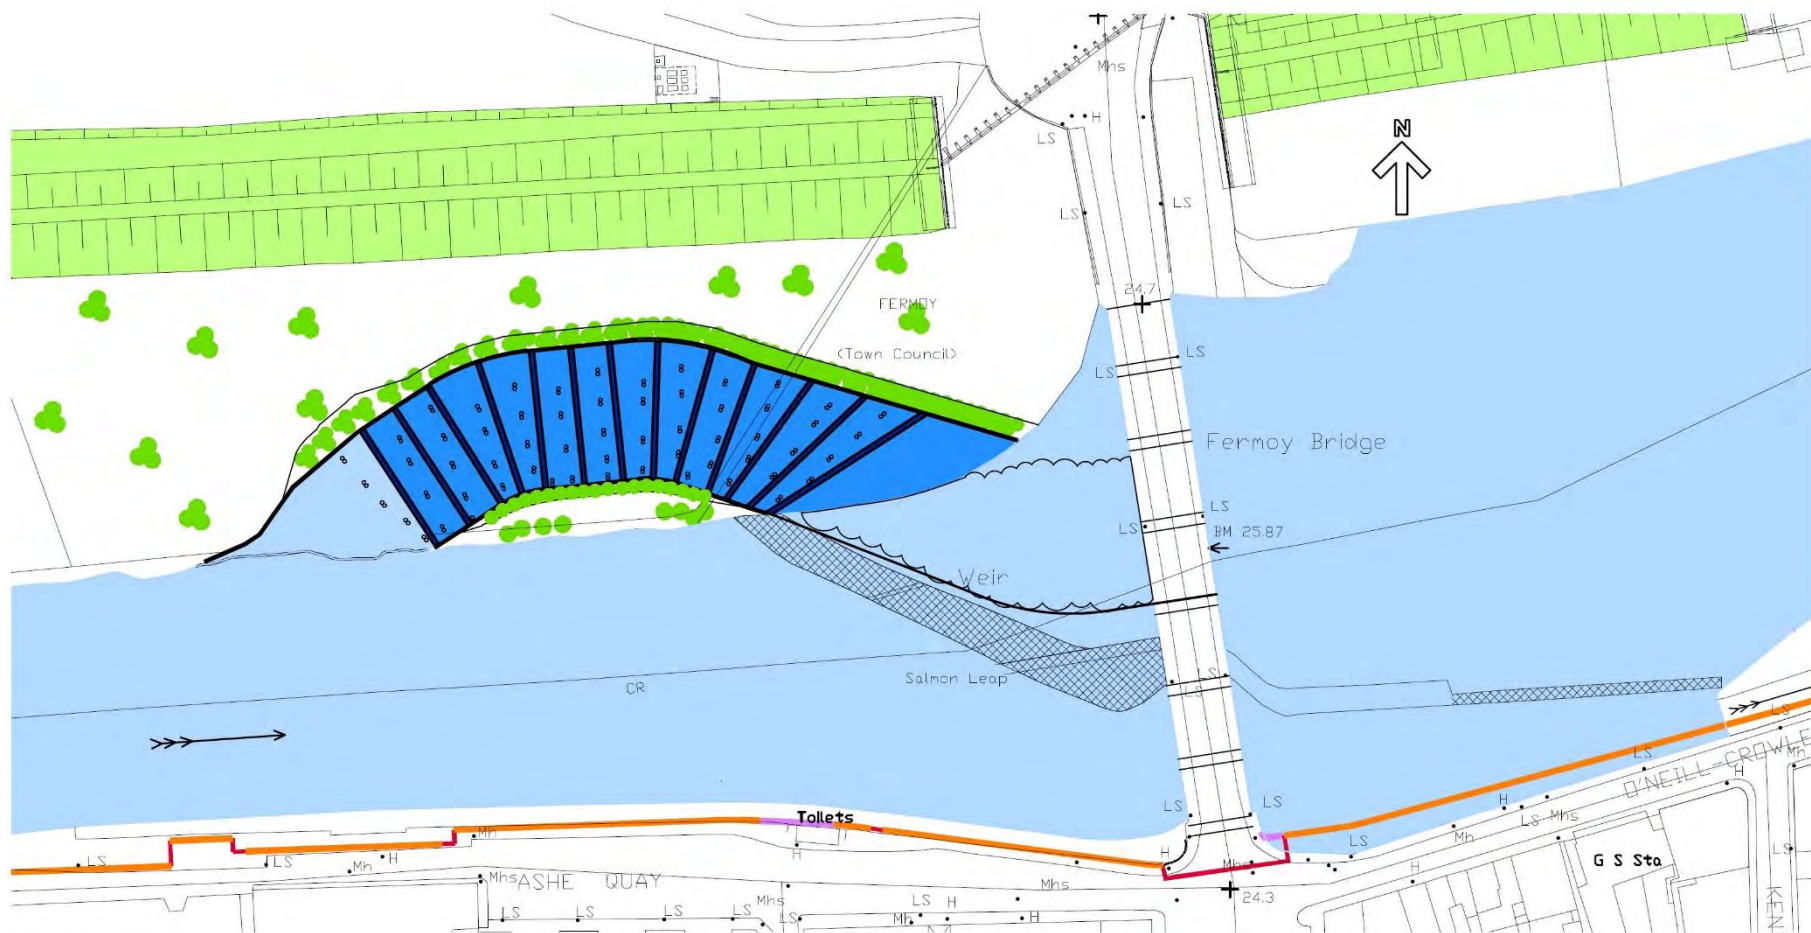
9. Rough Channel Pool Bypass

Maintains Upstream Water level
